## **INTRODUCTION**

The Bradford Peverell Parish Plan was initiated by the Parish Council (PC) and is based on the views expressed by its residents. It was completed in 2012 and covers the period to 2017.

Amongst others, a Traffic Steering Group was formed to work with the PC to look at concerns raised in the Parish Plan.

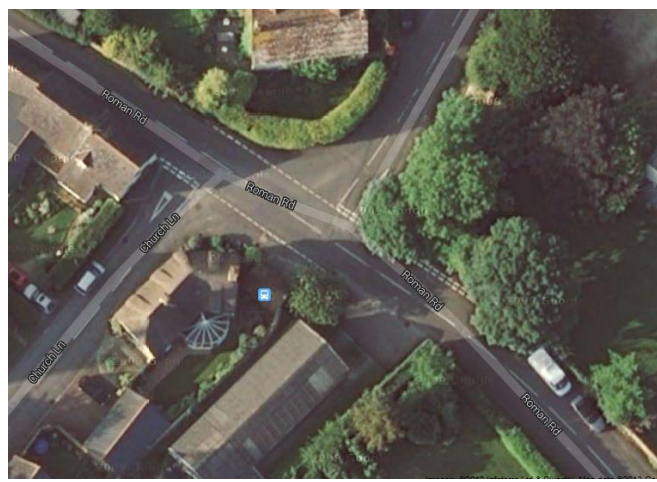
Figure 12 – Area 1 - Village Junction

3.3.1. This junction gives priority to traffic on the Dorchester - Muckleford road (Roman road), see Figure 12. The main area of concern is the limited entrance to the Village Hall and the lack of visibility looking left approaching the junction from the New Barn direction. When exiting the Hall, there is good visibility to the left, but to the right, the road is hidden by a high hedge.

3.3.2. The proposed changes to the junction remove all the road markings and priorities in favour of an open defined area, see Figure 13. This is in line with the suggestions and examples given in Reference 1.2.

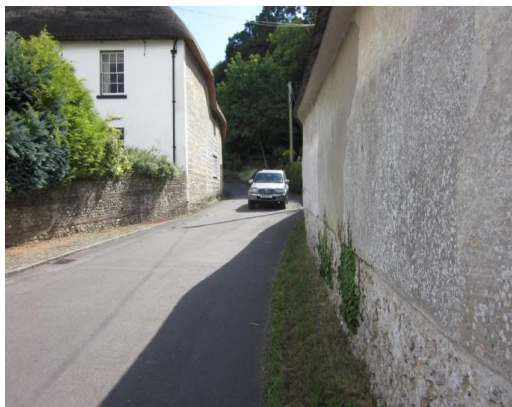
Figure 15 – View at Area 1 Looking Southeast

3.4.1. Area 2 is possibly the most hazardous stretch in the village where the road reduces in width to  $\approx 4.5\text{m}$ . This is compounded by the road being bounded on one side by a house and on the other by a wall. See Figures 15 & 16. Realistically, there is only sufficient room to allow two cars to pass with care, see Figure 15 & 16. Figure 17 clearly shows the problem of walking round this corner when two vehicles meet simultaneously.

- 3.4.2. In a similar fashion to the Village Hall junction, it is proposed that the identified hazard area has a change in road surface from Yew Tree Lane on the Northwest end to where the road diverges at the South Eastern end, see Figure 18.

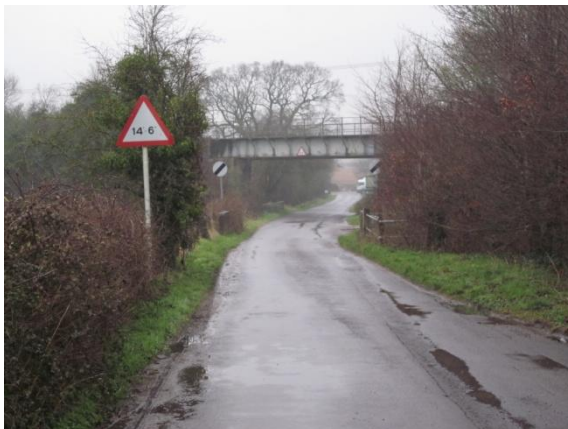
##### Signage 1

Height restriction sign at the village side of the railway bridge;-

Reposition onto the de-restriction sign nearer the bridge.

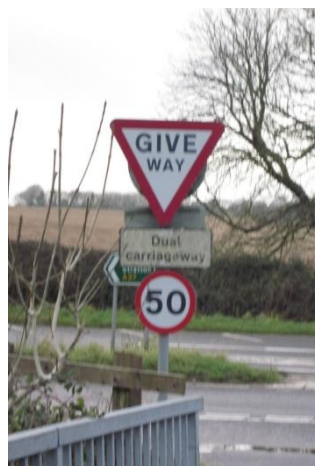
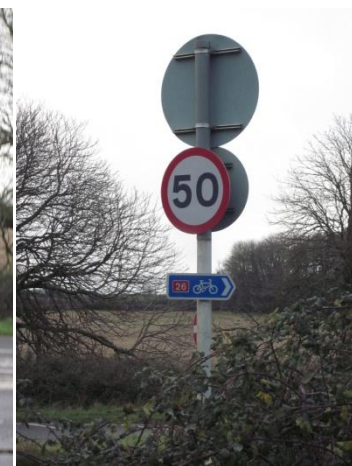
##### Signage 2

De-restriction sign entering and leaving the village to the A37;-

Remove the de-restriction signs leaving the A37 and reposition them on the village 30 mph limit, de-restriction side. This would remove the anomaly of leaving the A37 for the village going from 50 mph to 60 mph and finally, 30 mph in approximately 100 m.

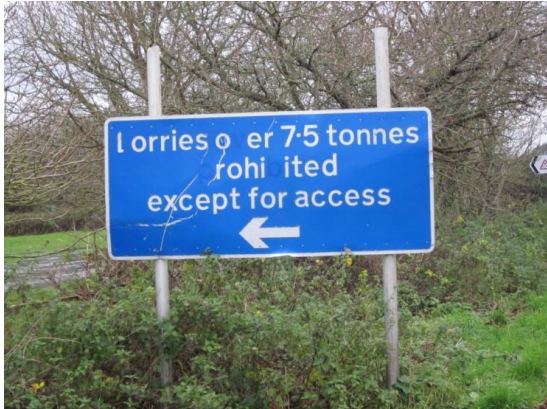
### **Signage 3**

Weight restriction signs;-

Remove the two blue weight restriction signs on the A37 as the warning is adequately displayed at other positions.

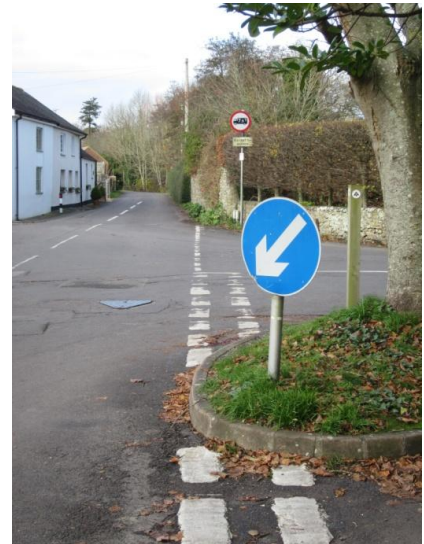
### **Signage 4**

Village direction sign;-

Remove the arrow sign opposite the village hall as it is superfluous to requirements.

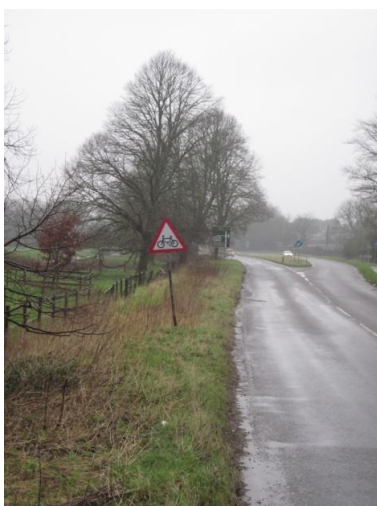
### **Signage 5**

Cycle Path sign approaching the village turning from the A37 going North West;-

The sign is redundant and should be removed.

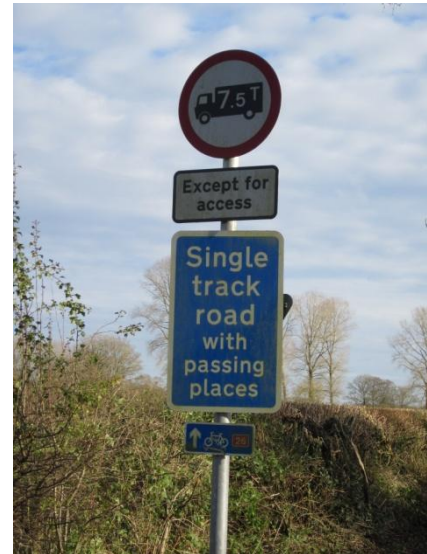
**Signage 6**

Back Lane from Muckleford;-

Incorrect Information at the start of the Lane to  
Bradford Peverell.

There are no authorised passing places.

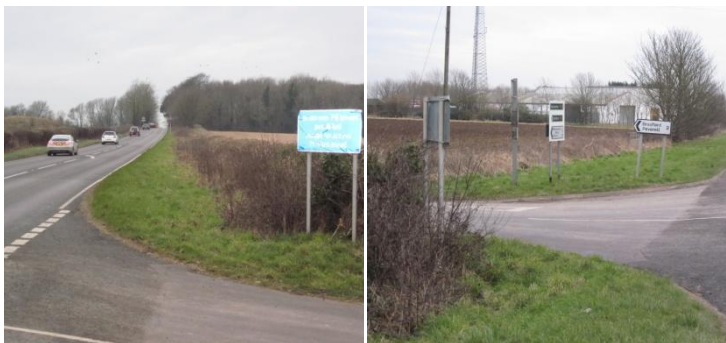
**Signage 7**

Weight restriction sign at Tilly  
Whim turning – A35 junction

No sign on the Eastern  
approach.

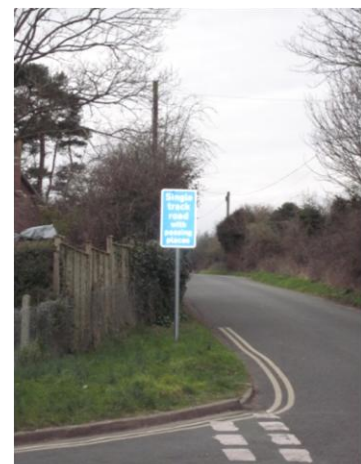
**Signage 8**

Back road from Normandy Way  
Single Track Road sign;-

No weight restriction or prior warning of limiting  
height of railway bridge in Bradford Peverell.
